Chapter 3

Compliance Audit

PUBLIC WORKS (ROADS) DEPARTMENT

3.1 Wasteful expenditure

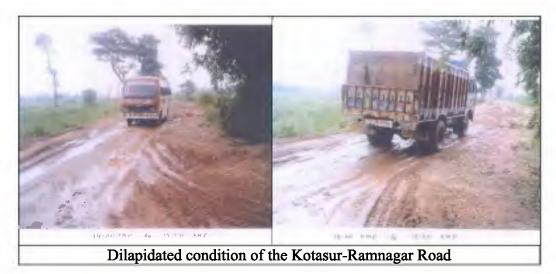
- Bituminous work of the entire stretch of the road was damaged soon after (June 2010) completion of the work.
- ➤ It was reported (June 2010) by the Assistant Engineer that damage was due to failure of sub-grade since crust thickness provided in the project (360 mm) was inadequate and it was required to be 625 mm based on the CBR and traffic census.
- Executive Engineer proposed re-construction of the road after proper investigation of the sub-grade soil with the help of expert group.
- The Department took three years to assign the study to the Expert Group *i.e.* Road and Building Research Institute (RBRI), Public Works (Roads). RBRI investigated the condition of the road and recommended (July 2014) its reconstruction with 680 mm crust thickness based on CBR value of 3.67 per cent and msa value of 7.72.

Audit observed that though the Project Report of the work taken up in November 2007 envisaged 485 mm of crust thickness, the work was awarded with provision of 360 mm crust thickness in violation of the IRC guidelines.

The division had to incur ₹ 62.11 lakh on repairs of road between 2010-11 and 2012-13, but the road could not be made trafficable and public transport had to be stopped.

Thus, due to consideration of inadequate crust thickness, the road became dilapidated soon after completion of the work, rendering expenditure of ₹ 4.54 crore⁵¹ on bituminous works and maintenance of the road wasteful, besides affecting traffic movement on the road.

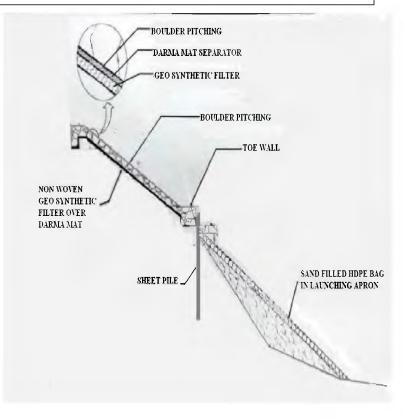
Audit scrutiny revealed that a stretch of 750 metre of the protective work was washed out completely between August and September 2013. The concerned EE reported (September 2013) that the failure was due to movement of launching apron material below toe-wall. Director, Central Design Office (CDO), Irrigation and Waterways Department carried out inspection

- Audit observed that as per IS Code⁵⁶ when firm strata is not available at a reasonable depth below the river bed, toe protection in form of sheet piles⁵⁷ is recommended. The division, however, constructed toe wall with boulder sausage without adequate support. CDO observed that failure of slope pitching was triggered due to settlement of toe boulders as toe wall did not get adequate support from the apron and was supported on an elevated and unstable sloped surface.

- Launching apron is projected from toe wall into the river, so as to prevent scour⁵⁸ at toe and consequent fall of slope pitching. As per the code, stones in the apron should be designed to launch along the slope of the scour and provide a strong layer that may prevent further scooping out of the river bed materials. Audit observed that launched apron with nylon crated sand bags of length 16.97 m was considered in the estimate against the required length of 28.13 m (considering actual scour depth observed). Thus, the whole of the scoured face was not adequately protected and left open to erosion which could not prevent further scouring and resulted in slippage of toe wall. CDO in its reports also observed that thickness of apron was extremely minimal at the junction of toe wall and suggested that thickness of apron should be sufficient and as per the IS code.

- Audit also observed that as per the IS Code⁵⁹, a graded filter (like gravel/metal/crust rock/sand) of 150 to 300 mm thickness should be provided below the revetment to prevent failure by sucking action of high velocity flow⁶⁰. But in the present work, filter material laid beneath the boulders was woven type geo-synthetic membrane⁶¹ and "darmamat" was used as separator between filter and boulder. CDO also observed that close proximity of filter material and boulder pitching had not been achieved due to presence of 'darma mat' which was stiff and of non-flexible material.
